NBSIR 87-3546

Corrosion Evaluation of Underground Telephone Cable Shielding Materials

J. L. Fink, D. Mathews, G. Hessler, and E. Speed

January 1988

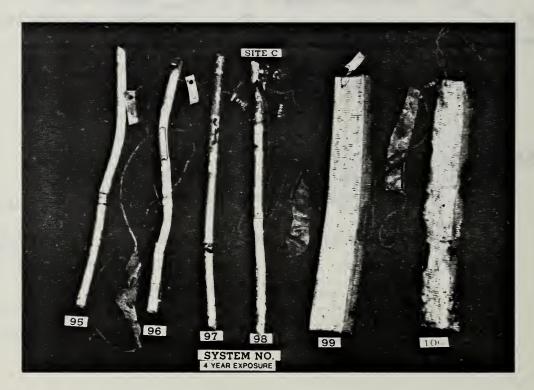
Figure 3. Outer Shield: Systems 95, 96, 97, and 98, Inner Shield: Systems 99 and 100, left to right, exposed at Site C for four years. Severe corrosion on System 98 at the window and ring areas, with severe corrosion on System 96 at all areas.

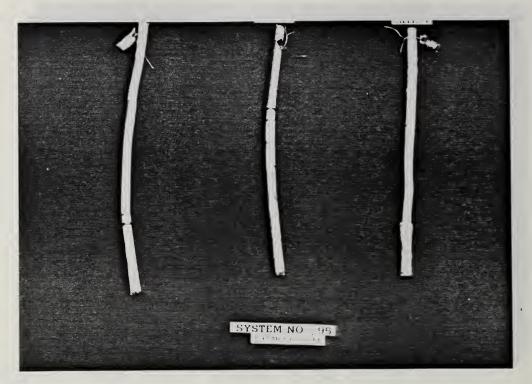
Figure 6. Outer Shield: System 95, Sites B, D, and G, left to right, exposed for five years.

Severe degradation at all areas on the specimen from Site G.

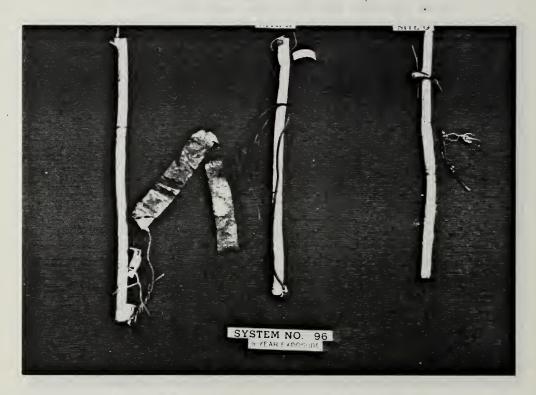
Figure 7. Outer Shield: System 96, Sites B, D, and G, left to right, exposed for five years.

Coupling this system to copper accelerated corrosion on the specimens from all sites.

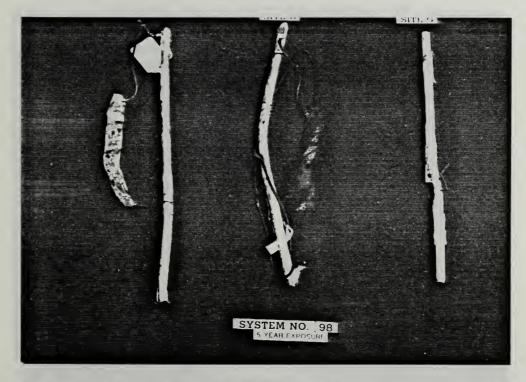
Figure 9. Outer Shield: System 98, Sites B, D, and G, left to right, exposed for five years.

Coupling this system to copper accelerated degradation at all areas on specimens from all sites.

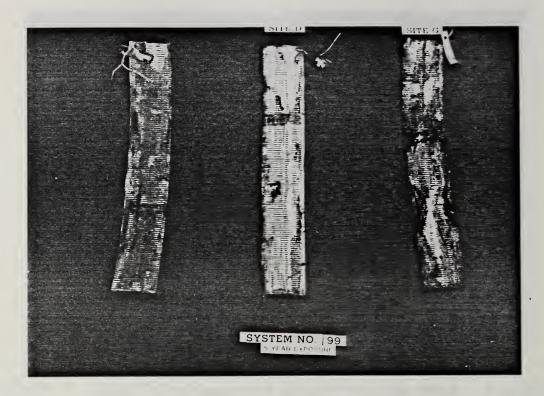
Figure 10. Outer Shield: System 99, Sites B, D, and G, left to right, exposed for five years. Dark areas indicate corrosion at the window and ring areas on the specimens from Sites D and G, with severe corrosion on the specimen from Site G.

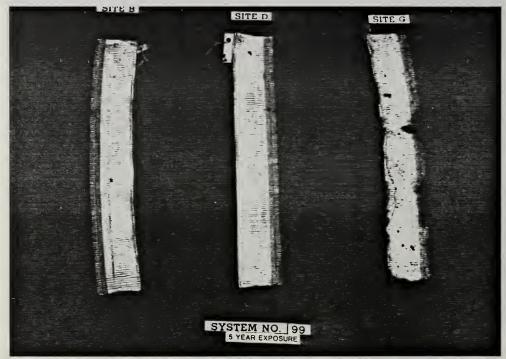
Figure 11. Inner shield: System 99, Sites B, D, and G, left to right, exposed for the five years.

Dark areas indicate corrosion at all areas on the specimen from site G.

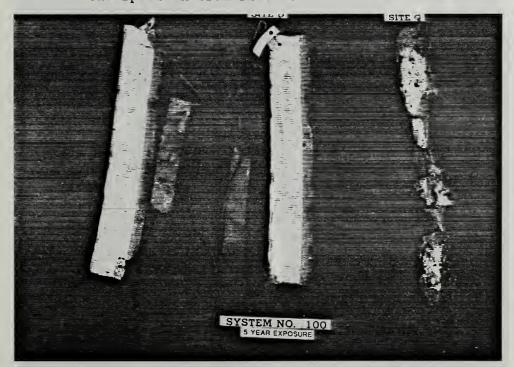
Figure 13. Inner Shield: System 100, Sites B, D, and G, left to right, exposed for five years.

Coupling this system to copper accelerated degradation at the window and ring areas, with severe degradation on the specimen from Site G.

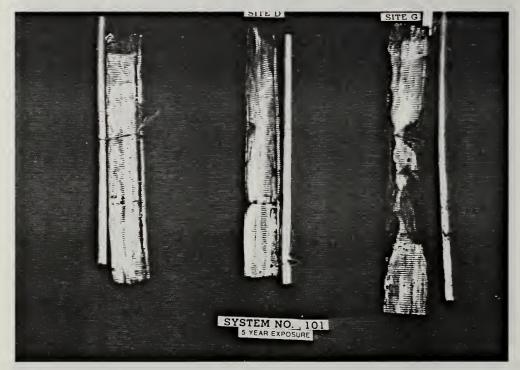
Figure 15. Inner Shield: System 101, Sites B, D, and G, left to right, exposed for five years. Dark areas indicate severe corrosion at the window and ring areas on the specimen from Site G.

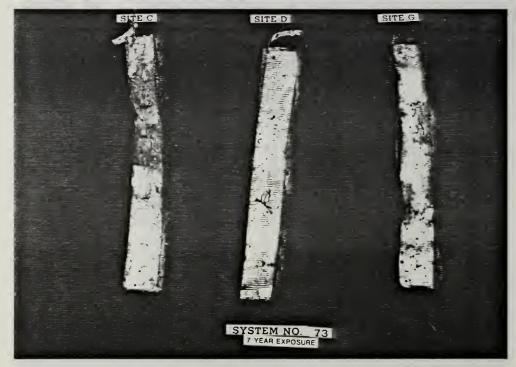
Figure 18. Inner Shield: System 73, Sites C, D, and G left to right, exposed for seven years.

alloy shield showed little effect by corrosion except at Site G where ELD, or near ELD, was observed at or adjacent to the window and ring areas on specimens exposed for three, four and seven years, while the inner aluminum alloy shield at Site C was ELD at all areas on the specimen exposed for seven years.

Severe degradation at all areas on specimens from Sites C and G, except at the under jacket area on the specimen from Site G, which remained excellent.

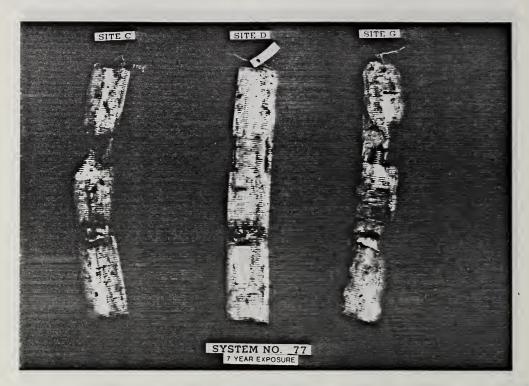
Figure 25. Outer Shield: System 77, Sites C, D, and G, left to right, exposed for seven years.

Dark areas indicate severe corrosion at all areas, except under jacket areas on specimens from Sites C and G.

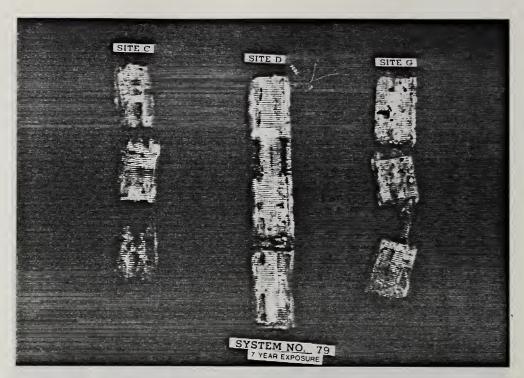
Figure 29. Outer Shield: System 79, Sites C, D, and G, left to right, exposed for seven years.

Severe corrosion at all areas on the specimens from Sites C and G.

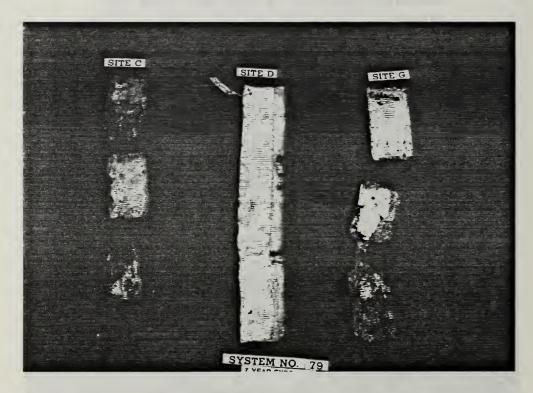
Figure 30. Inner Shield: System 79, Sites C, D, and G, left to right, exposed for seven years.

Severe degradation at all areas on specimens from Sites C and G.

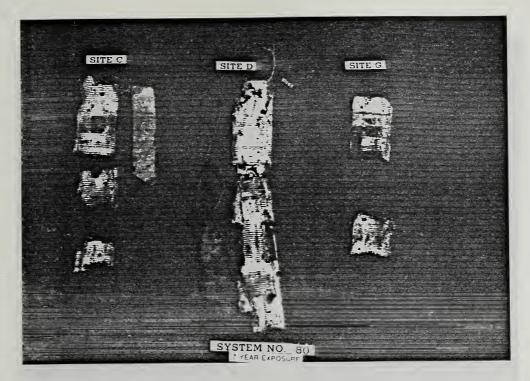
Figure 31. Outer Shield: System 80, Sites C, D, and G, left to right, exposed for seven years.

Coupling this system to copper accelerated corrosion at all sites.

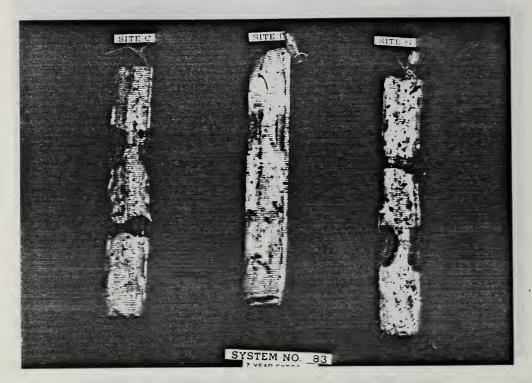
Figure 37. Outer Shield: System 83, Sites C, D, and G, left to right, exposed for seven years.

Dark areas indicate corrosion with severe corrosion at the window and ring areas on the specimens from Sites C and G.

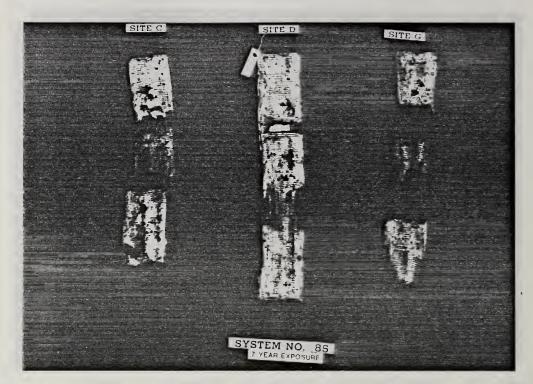
Figure 41. Outer Shield: System 85, Sites C, D, and G, left to right, exposed for seven years.

Severe corrosion at the window and ring areas on the specimen from Site G, with severe corrosion at all areas on the specimens from Sites C and G.

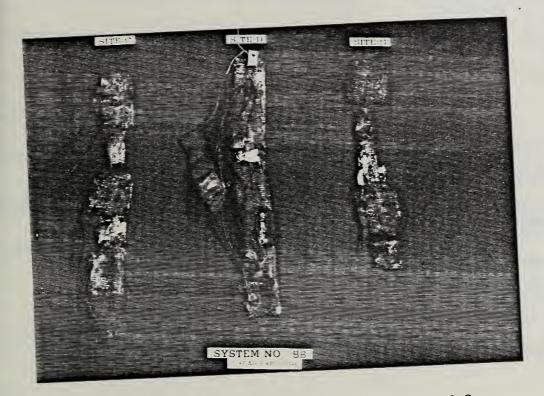
Figure 47. Outer Shield: System 88, Sites C, D, and G, left to right, exposed for seven years.

Coupling this system to copper accelerated corrosion severely at all areas on all specimens.

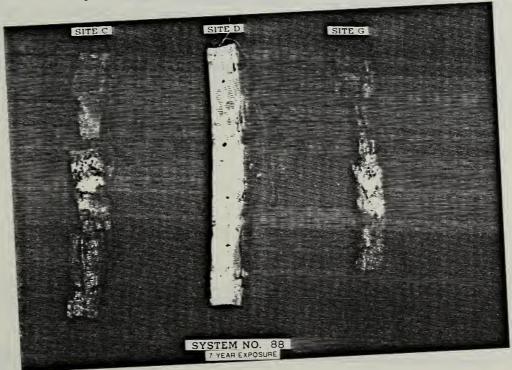
Figure 48. Inner Shield: System 88, Sites C, D, and G, left to right, exposed for seven years.

Coupling this system to copper accelerated degradation severely at all areas on all specimens.
